## BELZONA SEALS HYDRAULIC LEAK

August, 2009

Hydraulic system of press for stone products

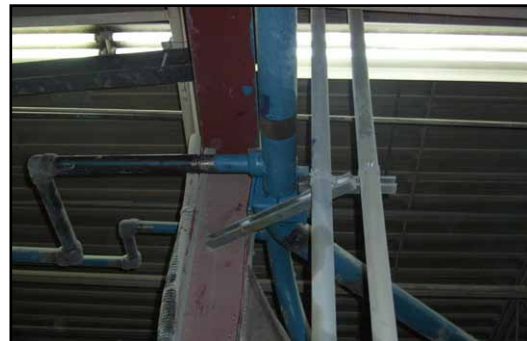
Hydraulic pipe had started to leak causing the fluid to drip onto the electrical circuit panel, causing a shutdown.

1. Leaking weld joint
2. Surface preparation
3. Completed repair
