BELZONA SAVES MONEY ON OIL-COOLER REPAIRS

Nuclear Power Plant, Russia

Oil cooler operating at up to 120 °C

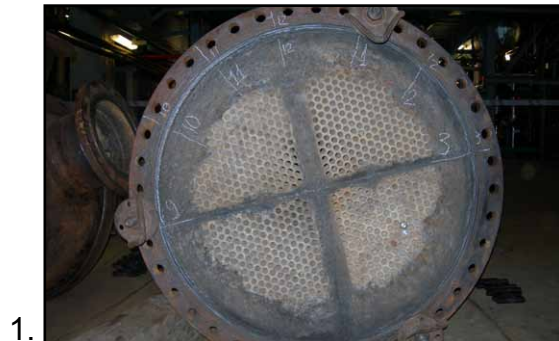
Due to the high temperature liquids, the sealing areas were eroded and corroded. Flanges, tubesheet and water box have been further damaged by corrosion.

1. Corroded tube sheet before application
2. First coat of Belzona® 1391
3. Forming of sealed faces
4. Rebuilding water box division bar with Belzona® 1111
