"DUCKS FEET" REFURBISHED WITH BELZONA

Power Station, UK

July 2005

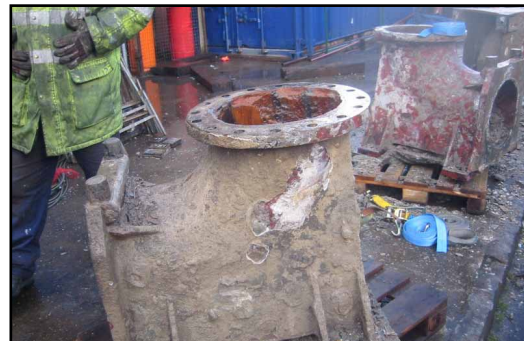
After 10 years in service these "ducks feet", situated at the bottom of the CW pipework, were found to be in very bad condition. There were 4 units to re-furbish.

1. As they arrived at contractor
2. Internal view showing severe damage
3. After blasting and re-building with Belzona® 1311
4. Fully coated with Belzona® 1321, looking rather better than when they arrived!

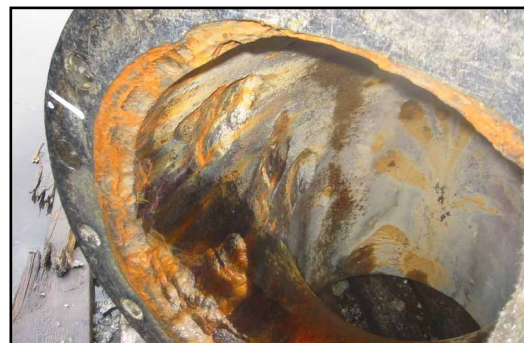
2.

Severe erosion, corrosion to body. The Power Station tried to order new ones but were told the delivery was upwards of 6 months! As they were right at the end of the shutdown this was not suitable.
