BELZONA EXPANSION JOINT THREE YEARS ON

Hospital, Charlotte, North Carolina, USA

Expansion joint in hallway.

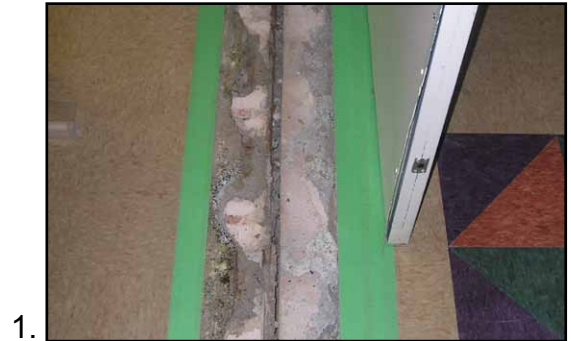
1. Joint taken out and fresh concrete exposed
2. Belzona® 4111 troweled into place
3. Ramp used to cover joint while product is curing
4. Finished joint 3 years on

The Belzona application was carried out in accordance with Belzona Know-How System Leaflets FPA-5 & -6. The old metal joint was torn out and replaced with Belzona® 4111. A jig was used to provide the repair with the same height as the tile floor. After removing the joint former, Belzona® 2211 was used to seal the joint. Belzona® 4411 applied for aesthetics.
