## TRANSFORMER LEAK SEALED WITH BELZONA

Power Plant, Lithuania

September 2009

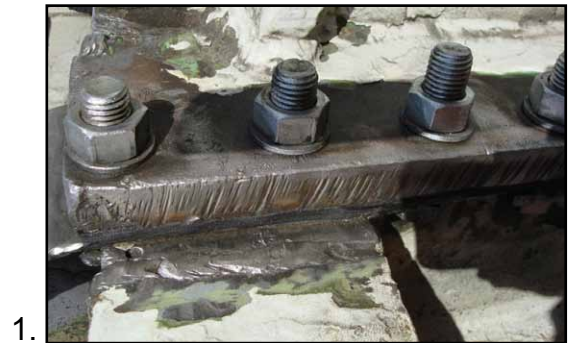
1. Paint and other contamination removed
2. Substrate roughened
3. Belzona 1161 and Reinforcement Tape applied
4. Second layer of Belzona 1161
