BELZONA REBUILT HEAT EXCHANGER COVER

Ship Dockyard, Bulgaria

Top-cover of heat exchanger

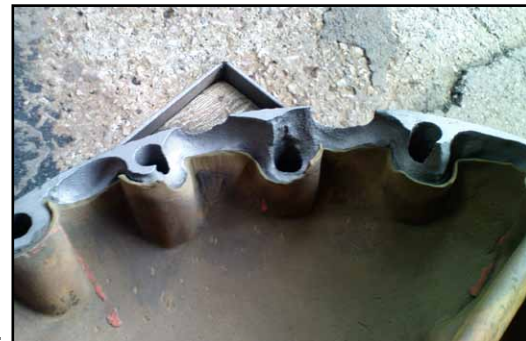
Damage on the original profile of the cooler top-cover due to erosion/corrosion, led to leaks and loss of efficiency.

1. Damage to top-cover clearly evident
2. Formers were used to restore profile
3. Repair of top-cover flange face in progress
4. Finished repair

Application was carried out in accordance with Belzona Know-How System Leaflet HEX-2. After blasting the damaged area and flange surfaces of the top-cover were restored by forming technique and Belzona® 1111.
