BELZONA PROVEN CAVITATION PROTECTION TO FRANCIS TURBINE

Hydroelectric plant, Slovakia

Francis turbine runner

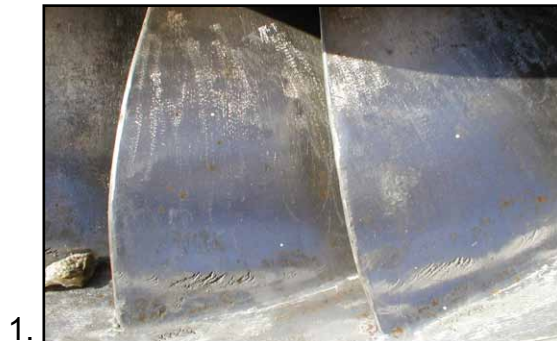
Cavitation had caused erosion of the metal and loss of turbine performance. Belzona® 1311 and Belzona® 1341 had been applied in 2004, but had suffered further cavitation, so system upgraded by applying more cavitation resistant Belzona® 2141.

1. Cavitation damage to turbine runner
2. Belzona® 1341 showing some cavitation damage
3. Belzona® 2141 being applied to the runner
4. After 24 months service Belzona® 2141, inspection shows no further cavitation damage

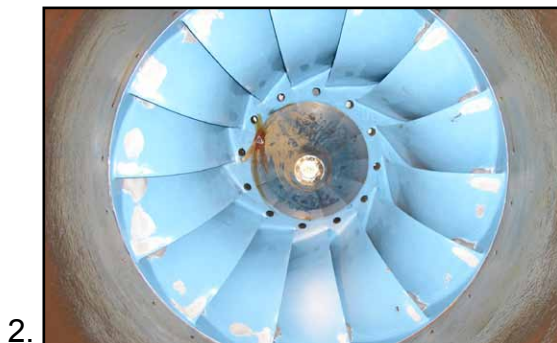
Inspection of the Belzona Ceramic coating in 2006 showed damage from cavitation, so specification was changed to Belzona® 2141. Further inspection after 2 years showed no damage on the turbine runner.
