## BELZONA RECONSTRUCTS STREET SWEEPER FAN

Fan from a Busher type sweeper truck

Wear on the blades of the fan. Customer wanted to avoid replacing the part.

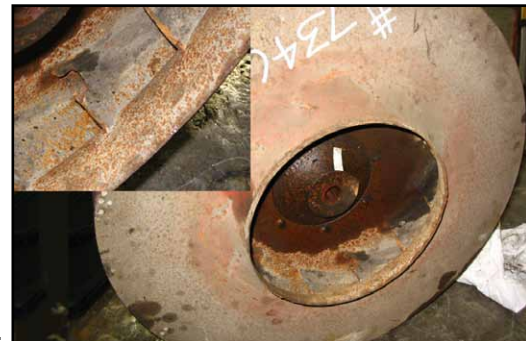
1. Overall view of the fan and the wear on the blades
2. Steel plate being shaped in place
3. Plate being placed and coated with the Belzona 1311
4. Inspection after 3 years shows no significant wear

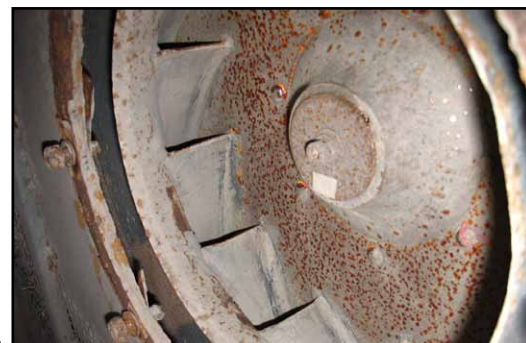
4.

The customer saved \$4000 from an investment of only \$400 in Belzona because the fan didn't need to be replaced. An inspection 3 years later showed no significant wear.
