## STREET SWEEPER FAN PROTECTED WITH BELZONA

Local municipality, Québec Canada

Elgin type of street sweeper

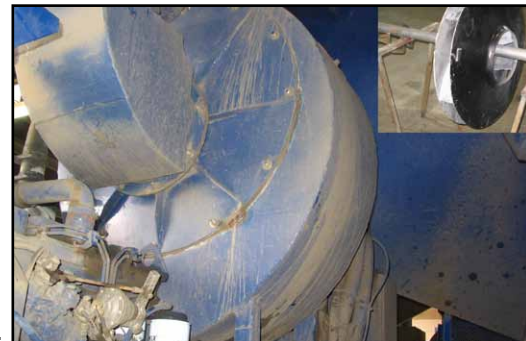
1. Location of the fan on the vehicle
2. View of the damage to the fan
3. Application of Belzona® 1311. The fan needs dynamic balancing before being used
4. The inspection after one year shows the Belzona® 1311 in excellent shape

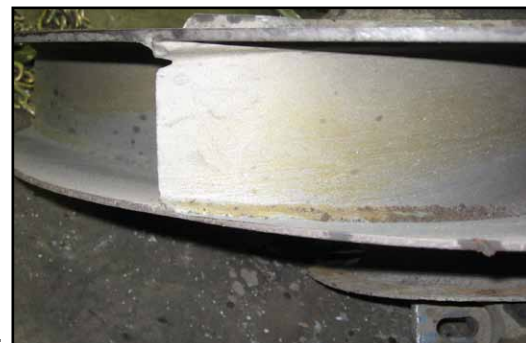
2.

The blades on the fan are submitted to severe abrasion caused by solid particles entering the street sweeper.

Application carried out in accordance with Belzona Know-How System Leaflet FBC-15. Expanded metal was used with the Belzona to re-create correct profiles.

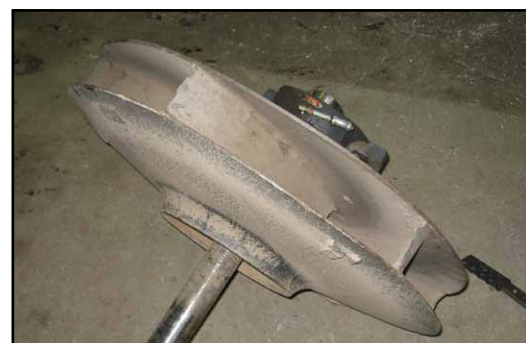
4.

The customer invested in 2 units of Belzona® 1311 and saved on a brand new fan which would have cost \$4000.00. After 500 hours, one season, the fan is in excellent condition and no touch up was necessary.
