BELZONA REBUILDS FLANGE FACE ON FILTER

Hydroelectric Power Plant, Russia

December 2007

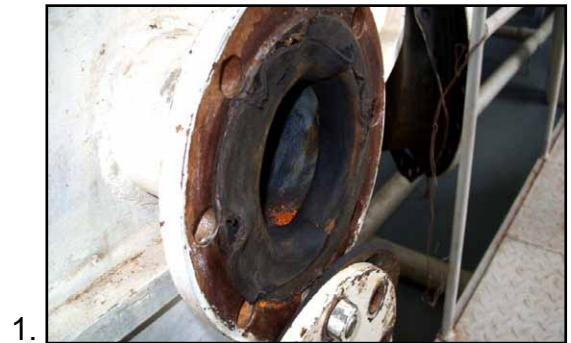
Rubber had been damaged due to long years in service and was badly deteriorated. Sealing of the flange lost. Rubber in seal area had lost adhesion to the substrate.

1. Deteriorated flange face before the application
2. Surface preparation to flange face
3. Completed application
