BELZONA FIXES DRAINAGE PROBLEM

Office Building, Ontario Canada

Parking garage storm drain

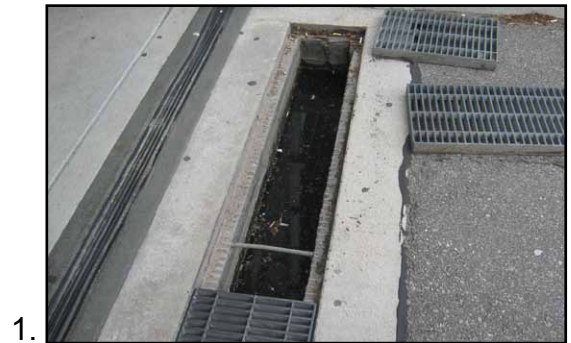
Previously installed coating system had failed and was stopping the water or anything else from draining out.

1. Water and trash not able to escape
2. Removing the old system
3. Grinding back to white concrete
4. Belzona® 5811 applied
