BAROMETRIC CONDENSER PROTECTED WITH BELZONA

Oil Refinery, Pennsylvania USA

New Barometric Condenser for Major East Coast Oil Refinery

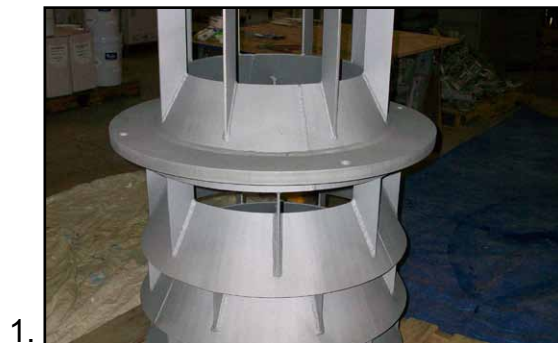
1. White metal blast
2. Additional components after blasting
3. Condenser coated
4. Coated flange face

Application was carried out in accordance with Belzona Know-How System Leaflet HEX-3.
