BELZONA SEALS DIESEL LEAK IN 60 MINUTES

Oil Terminal, New Jersey USA

Diesel storage tank located at a terminal of a major oil company

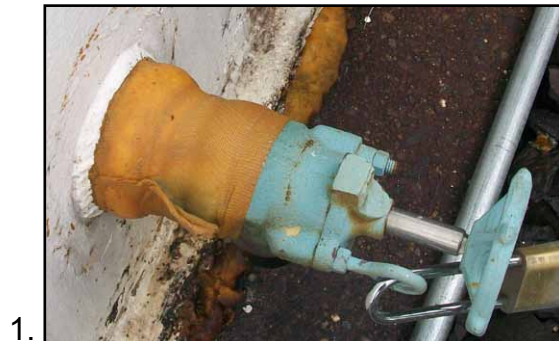
A valve located at the base of the tank was leaking. Terminal personal had attempted to seal the leak using an off the shelf water activated fiberglass wrap. They were unsuccessful. And the valve continued to leak.

1. Failed fiberglass wrap
2. Roughening the surface
3. Surface prepared and degreased
4. Application completed

Application was carried out in accordance with Belzosa Know-How System Leaflet VPF-11a. the failed fiberglass wrap was removed, the surface was prepared before wrapping the live leak with Belzona® 1221 and Belzona® 9341 (Reinforcement Tape).
