BELZONA REPAIRS HOLED CLARIFIER

Chemical plant, New Jersey USA

Waste Water tank at a Chemical Plant

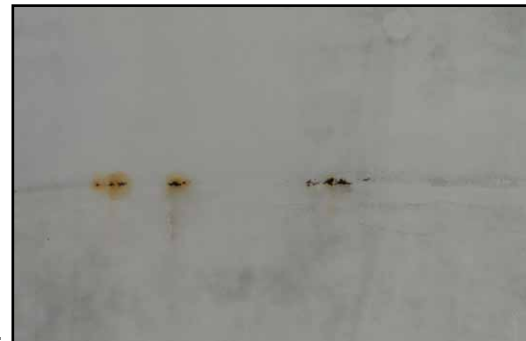
Corrosion along the water line had resulted in a series of holes and thin areas around the entire circumference of the tank.

1. Holes in tank wall
2. After grit blasting supports were bonded with Belzona® 1211
3. Belzona® 1121 being applied to shell
4. Exterior completed
