BELZONA SOLVES KITCHEN TRIP HAZARD

Hospital, Charlotte, North Carolina USA

Transition between a rubber floor and a tiled floor.

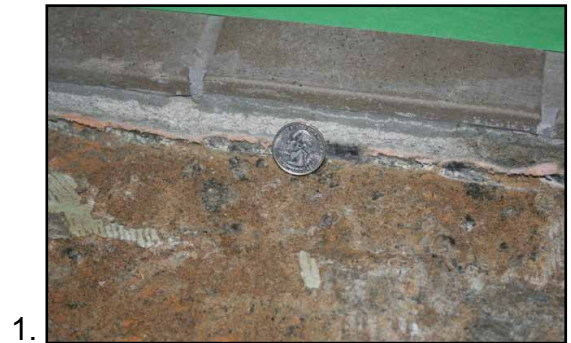
There is a big transition which was causing a trip hazard as well as limiting cart traffic.

1. Coin shows the transition step
2. Exposed concrete after rubber floor removal.
3. Applying the Belzona 4111
4. The finished job
