BELZONA RESTORES COOLING WATER PUMP

Main circulating water pump at refinery.

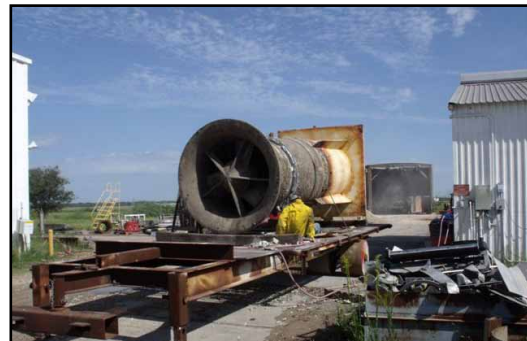
1. Circulating water pump
2. Damaged suction bell
3. Impeller coated with Belzona® 1341 together with rebuilt and coated suction bell
4. Pump discharge coated with Belzona® 1341

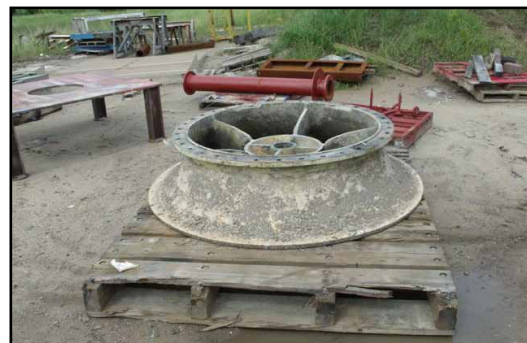
General corrosion over many years had degraded the operation of the pump.

Application was carried out in accordance with Belzona Know-How System Leaflets CEP-1 & -3. All pitting was rebuilt with Belzona® 1111. After the rebuild was complete two coats of Belzona® 1341 applied.
