BELZONA REPAIRS CASING OF CEMENT BALL MILL

Cement plant, Egypt

Ball mill used to grind limestone in cement production.

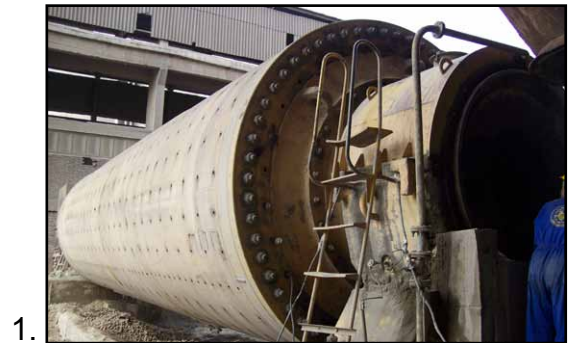
1. General view of the mill.
2. Wear on the shell after dismantling the plates.
3. Application of Belzona® 1121.
4. Completed application.

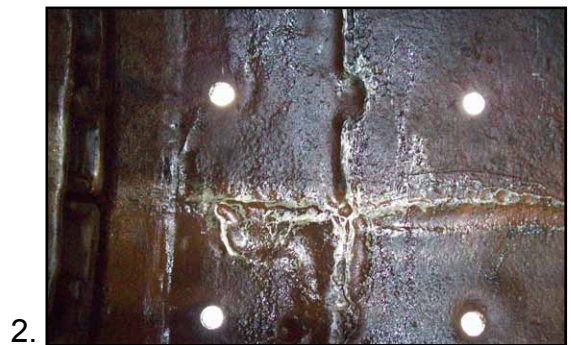
Wear on the casing needed to be rebuilt before the bolting of the new wear plates.
