BELZONA PROVIDES ROOF PROTECTION

Software Distributor, UK

Steel corrugated pitched roof with large channel gutters running the length of the roof. The roof had several pipe penetrations, ventilation ducts and rooflights.

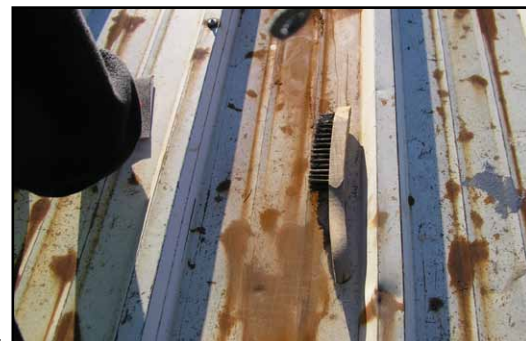
New extension was suffering from leaks due to attack from bird litter and excrement which was chemically attacking the plastic coated steel sections.

1. Corrosion issues due to bird litter on roof extension
2. 1990 application unaffected by bird litter
3. 2005 application completed
4. 2010 still is perfect condition

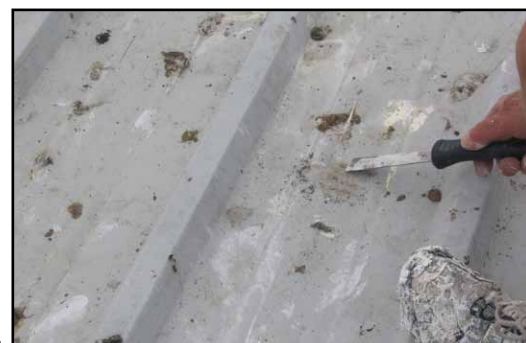
2.

The original roof was completed in 1990 by the local Authorized Contractor. It was possible to see corrosion as a result of bird litter on sheets of the new extension but on the Belzona® 3111 Membrane System it has had no effect on performance although a wash would make it more aesthetically pleasing. As a result of the success on the original roof, the extended building was then encapsulated and the existing system refurbished to provide a further 15 years life.
