## BELZONA REPAIRS SPALLED CONCRETE

Community College, Newcastle

Local authority housing stock with concrete cantilever balcony construction and steel handrails.

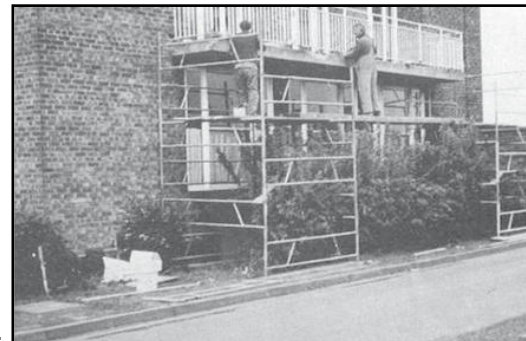
1. Community College in 1980
2. Spalled Concrete
3. Community College in 2007
4. Application revisited

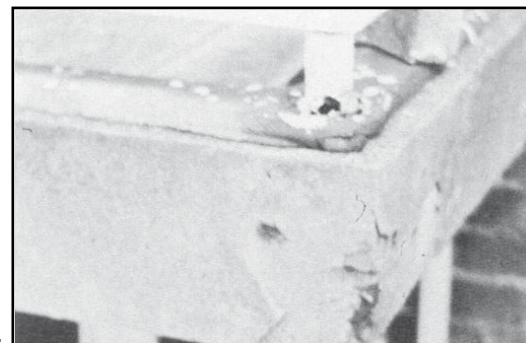
2.

Concrete balcony had suffered from spalling due to the detrimental effects of the environment and concrete cover below the minimum for protection of the reinforcing bar.

Application was carried out in accordance with Belzona Know-How System Leaflet RPA-2. Lightweight Belzona® 4141 system would now be specified as it requires no permanent shutter/formwork. This would have made the job even easier to carry out.

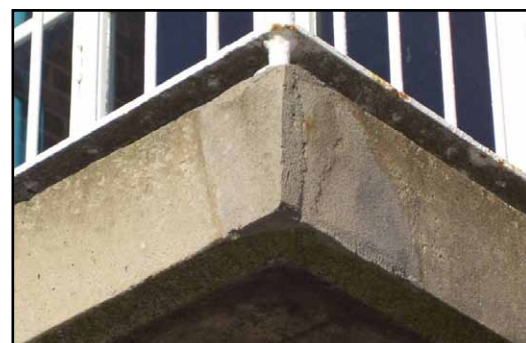
4.

The initial application was quick and eliminated any potential safety risk due to unsafe concrete falling from the two storey building. Twenty seven years later, Belzona revisited the application to find that it was still in excellent condition with no signs of further spalling, carbonation, shrinkage or cracking.
