## BELZONA PROTECTS POWER STATION CHIMNEY STACK

Coal Fired Power Station, Yorkshire, England

Top section of exhaust gas chimney stack.

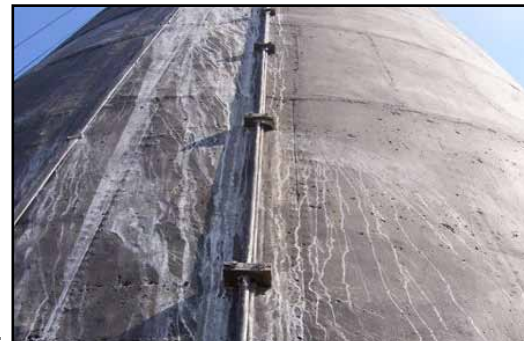
Existing coating was beginning to degrade due to exhaust gases and ultra-violet (UV) breakdown combined with inclement weather.

1. Existing coating degrading
2. Application of Belzona® 5111
3. Completed application in 2008
4. Application revisited in 2010
