## BELZONA PROTECTS HEAT EXCHANGER TUBE SHEETS

Chemical Plant, Mexico

Heat exchanger tube sheets in Chemical plant.

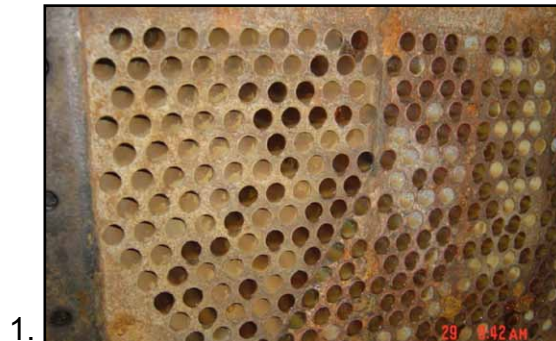
Erosion corrosion protection required on tube sheets to prevent further loss of metal that could otherwise lead to leakage, loss of efficiency and contamination.

1. Corroded tube sheet
2. After grit blasting
3. 1st coat of Belzona® 1321
4. Completed application with corks removed from tubes
