BELZONA PROVIDES POSITIVE GRIP TO DRIVE ROLLER

Fertilizer plant, Bulgaria

Conventional rubber cladding conveyor drive roller (diameter 800 mm and length 1400 mm) for transporting fertilizer production

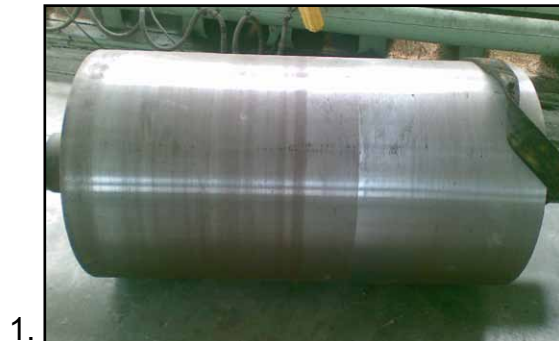
Pieces of rubber cladding were frequently torn away due to build up. In addition severe wear from excessive moisture, chemical attack and abrasive media was causing belt slippage.

1. Drive roller with just removed old rubber cladding
2. Grit blasted drive roller
3. Belzona non-slip chevron designed surface being applied
4. Completed application and drive roller ready for service
