BELZONA FLOOR UPGRADE PROVIDES ENVIRONMENTAL PROTECTION

Telecom company, Montreal, Canada

Floor area where hazardous materials are stored.

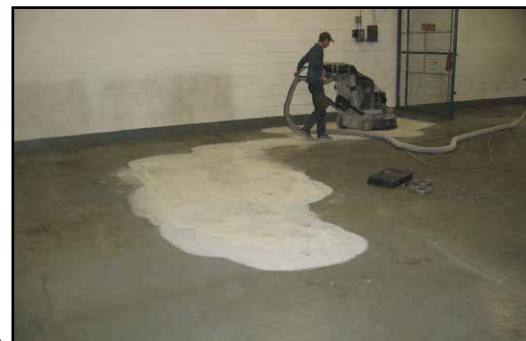
1. Floor being abraded
2. Aluminium angles sealed with Belzona® 1121
3. Belzona® 5811 being applied
4. Completed application

Application was carried out in accordance with Belzona Know-How System Leaflet FPA-3. Aluminum angles were bonded to wall/floor junction to create sealed coving prior to coating entire area with Belzona 5811
