## BELZONA PROTECTS HEAT EXCHANGER HEAD

Chemical plant - Gulf Coast, USA.

Heat exchanger end cover.

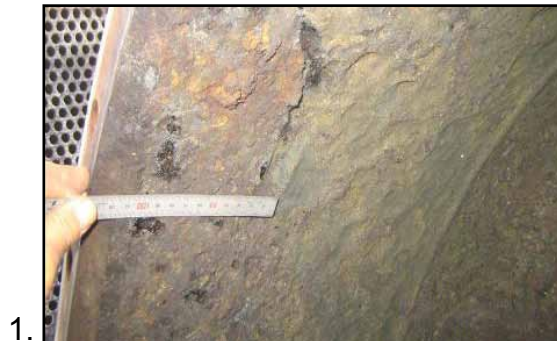
Severe corrosion occurring due to source water. corrosion rate estimated at 0.05" (1.25mm) per year.

1. The rapid metal loss through corrosion clearly evident
2. Surface preparation completed
3. Close up of application
4. Completed head
