BELZONA SEALS LEAKING OIL PUMP

Oil company, Japan

January, 2010

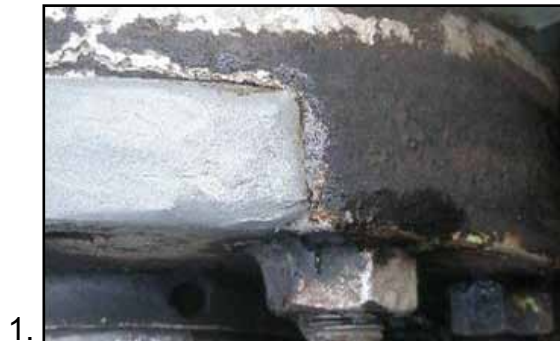
Oil was leaking from several parts of mechanical seal flanges.

1. Seal area before application
2. Surface preparation completed
3. Application of Belzona 1221
4. Application completed

Application was carried out in accordance with a modified version of Belzona Know-How System Leaflet VPF-11a. Surface was prepared with an MBX Bristle Blaster and initial leaks were temporarily sealed with Belzona 1221 before permanent sealing with Belzona 1161.
