BELZONA REPAIRS SEDIMENT COLLECTOR DRAIN PIPE

Sediment removal equipment for Condenser water feed

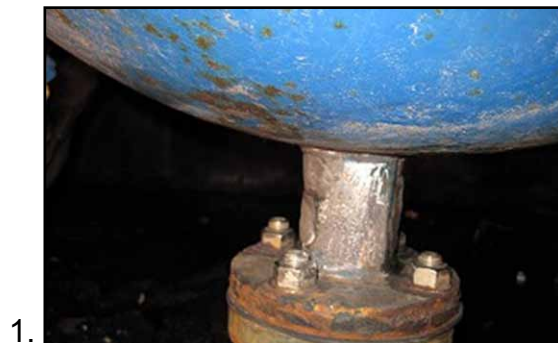
1. Surface preparation completed
2. Leak stemmed with Belzona 1291
3. Belzona 1161 and Reinforcement Tape applied to complete repair

Application was carried out in accordance with Belzona Know-How System Leaflet VPF-11a. Belzona 1291 was used to stem the live leak. Once no leaking was ensured, Belzona 1161 plus Belzona 9341 (Reinforcement Tape) was immediately used to overcoat the area to create a permanent repair.
