BELZONA REPAIRS LIVE LEAK ON TRANSFORMER

Pipework on oil filled transformer.

Oil leak causing environmental contamination.

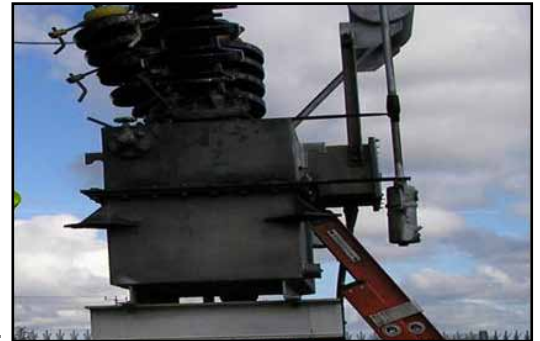
1. Leak area
2. Leak stopped with Belzona 1291
3. Application completed with Belzona 1161
