TRANSFORMER FLANGE SEALED WITH BELZONA

National Grid, UK

Transformer

Oil leaks at the bolted flange joints connections

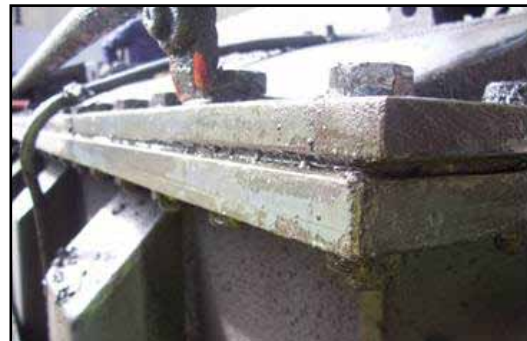
1. Leak area
2. MBX Bristle Blaster used for surface preparation
3. Belzona 9341 and Belzona 1161 applied to the flange joint
4. Application completed
