## BELZONA SEALS SF6 LEAKS ON CIRCUIT BREAKER

Electrical distribution substation, Australia

Bushing on 330kV circuit breaker.

SF<sub>6</sub> gas leaks through porcelain bushing seal

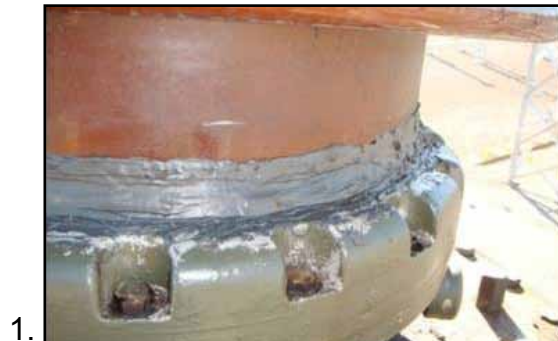
1. Original unsuccessful repair (still leaking)
2. Prepared area using the MBX Bristle blaster
3. Applying the Belzona 1161
4. Close up of the completed repair
