## BELZONA RESTORES HYDROGEN COOLER ENDS

Power Station, Ontario

November 2009

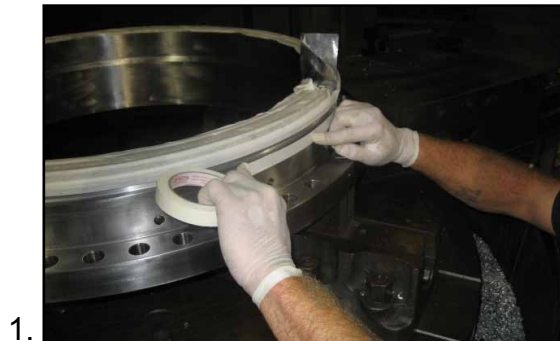
1. Unit set-up on turntable and upper and lower outside diameters masked off
2. Belzona® 1111 applied to build up the groove to the desired over-thickness
3. Seals ready to be machined to correct tolerance

Application carried out in accordance with Belzona Know-How System Leaflet MPT-9. Units are set up on a turntable and Belzona applied to rebuild groove before being re-machined to tolerance.
