## IMPELLER AT NUCLEAR PLANT REPAIRED AND PROTECTED WITH BELZONA

Nuclear Power Plant, North Carolina

Cooling tower Recirculation pump impeller.

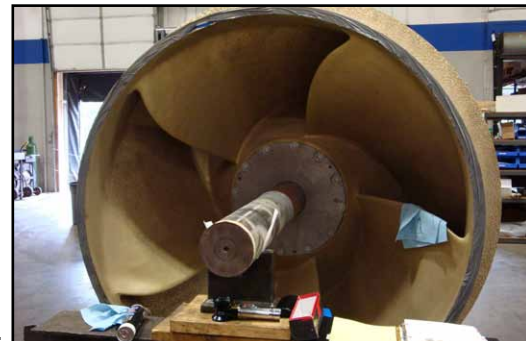
A combination of de-Aluminification over the surface of the impeller and cavitation at root of the vanes was causing a significant reduction in the efficiency of this pump.

1. Impeller before application of any product
2. Application of the 1st layer of Belzona® 1341
3. Application of the smoothing layer of Belzona® 1121
4. Belzona® 2141 applied to complete the job
