BELZONA KEEPS METAL CHURNING

Metals Plant, North Carolina, USA

Magnetic Cylinder, called a Stirring Jacket, used to mix molten Titanium.

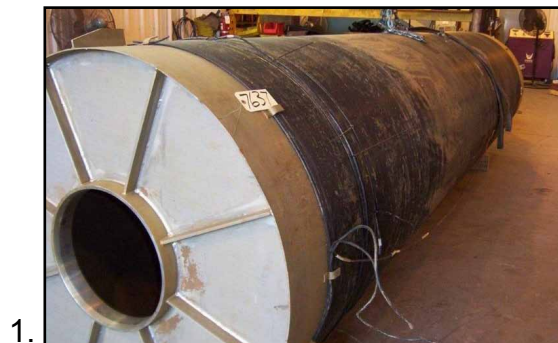
1. Stirring jacket wrapped in coil.
2. Cylinder prepared ready for application of first coat.
3. First coat being applied.
4. Cylinder after 18 months still "churning" away.

Application was carried out in accordance with Belzona Know-How System Leaflet GSS-1. Approximately one mile of #6 wire which supplied the current was removed. After surface preparation, one coat of Belzona® 2221 was applied, the coil was then re-wrapped, and a further coat of Belzona® 2221 was applied over the coil.
