## BELZONA REPAIRED STEPS IN GREAT CONDITION AFTER 5 YEARS

Local City Council, N.East England

Promenade steps on coast needing repairs.

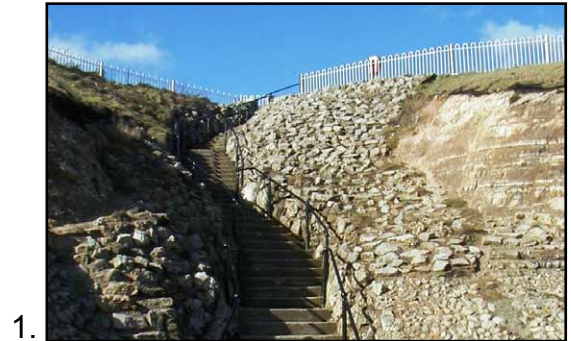
Due to the steps being on the sea front, over a number of years they had deteriorated where the nosings were damaged and in dangerous condition.

1. Steps before repair
2. Immediately after repair
3. Steps after 5 years use
4. Close up showing no deterioration after 5 years.

Belzona® 4131 (Magma Screed)

Application was carried out in accordance with Belzona Know-How System Leaflet FPA-1.

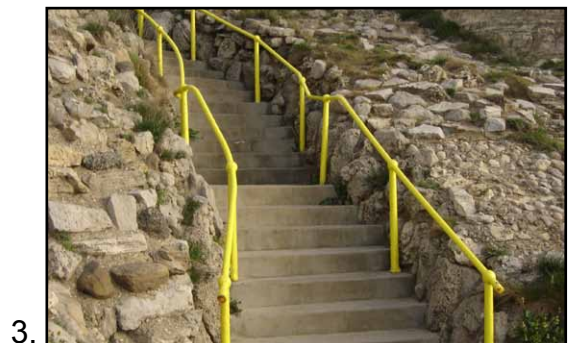
The customer had previously carried out localised repairs using alternative concrete repair materials. These products, however, were not effective due to poor adhesion and the nature of the coastal environment. An inspection of the Belzona repairs was carried out after 5 years and there is no signs of deterioration or damage to the step nosings.
