BELZONA KEEPS OS&D HOSE IN SERVICE

Liquid bulk storage terminal, NJ

Scuffs and tears to the cover of 8" OS&D (Oil Suction & Discharge) hoses.

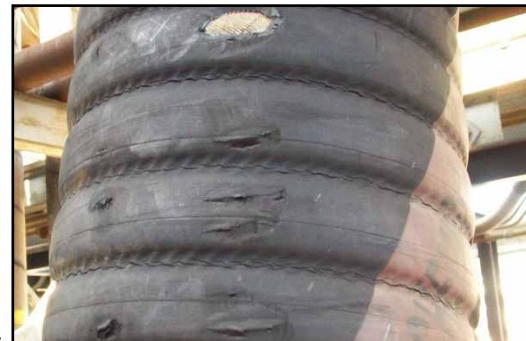
When inspected by the United States Coast Guard, even superficial scuffs and tears in the outer cover can result in hoses being tagged "out of service". Inspection showed that the reinforcement fabric had not been damaged.

1. Hose #9970 with 3 scuffed up areas exposing reinforcement fabric
2. Patch #3 area taped off and abraded
3. Patch #4 area taped off with Conditioner applied
4. Completed and ready for inspection
