BELZONA REPAIRS AND PROTECTS VESSEL SUPPORTS

Chemical plant, Bulgaria

Process vessel (mixer) in chemical production

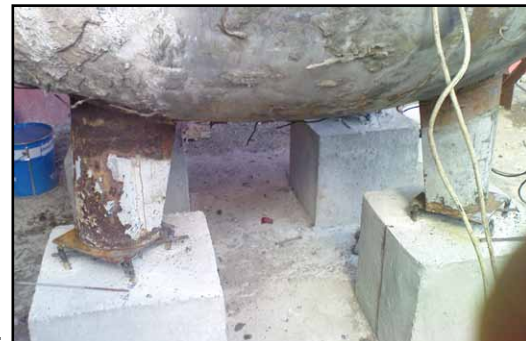
Uneven gaps (up to 70 mm) and additional deterioration of the concrete supports under mixer heels caused by chemical attack.

1. General view of process vessel heels and concrete supports
2. After preparation of substrates the Belzona Conditioner was applied
3. Application of Belzona® 4111 in progress
4. Finished application
