BELZONA PROTECTS CONCRETE IN BIODIESEL PLANT

Biodiesel Manufacturer, Memphis, TN

Concrete surfaces around biodiesel pumps and tanks

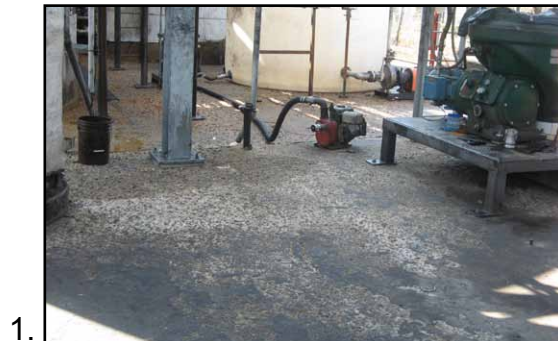
Biodiesel attacked the concrete substrate causing erosion leading to unsafe walking conditions.

1. Concrete pad before repair
2. Pad during repair
3. Completed project

Application was carried out in accordance with Belzona Know-How System Leaflet TCC-15. Surface was prepared with 20,000 psi pressure washer which removes deteriorated concrete and removes contamination at the same time. This repair was done over a 2 day period. Aggregate was applied into the Belzona® 5811 to create a non-slip walking surface.
