## EXTERNAL TANK CORROSION PROTECTION WITH BELZONA

Fuel distribution company, Tamaulipas, Mexico

Oil storage tank

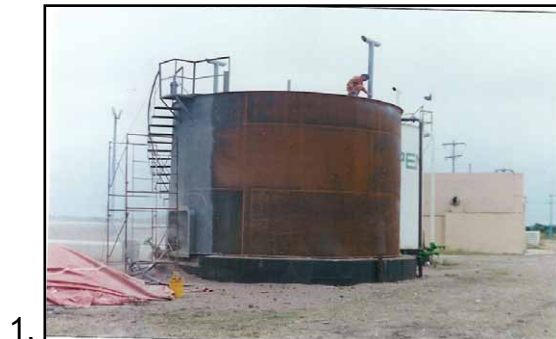
1. Surface preparation
2. Applying Belzona® 6111
3. Application completed
4. Tank ten years after application

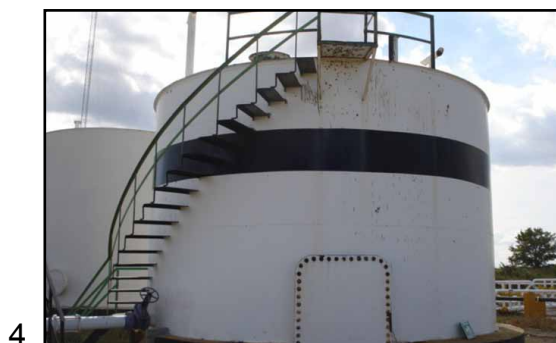
10 years after the application, the inspection showed the Belzona product was in perfect condition. The Belzona application saved the customer an estimated US\$ 39,500 through reduced maintenance costs.
