BELZONA REBUILDS BAKERY FLOOR

Bakery, Northern Ireland

Floor area around dough making machine.

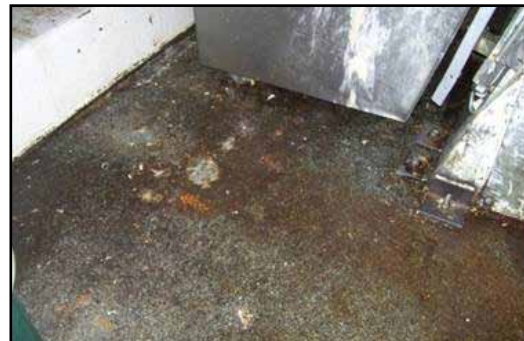
Oils, flour and cleaning water were going under the dough mixing machine. falls needed to be created to enhance drainage and ease of cleaning in this hygiene area.

1. Floor problem area
2. Floor area after cleaning and abrasion
3. Belzona Conditioner being applied
4. Floor area screeded with Belzona® 4131
