## BELZONA REPAIRS TRIP HAZARDS AT CIDER FACTORY

Cider Manufacturer, UK

Repairs to floor

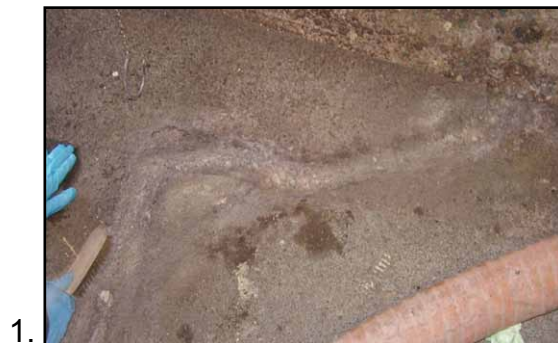
There are access lids at the base of the tank which are held in place with bolts and secured by a gasket to the base of the lid. However, these areas can be prone to leaking as the aggressive cider juice drips and eats away at the gasket and then attacks the concrete floor at the base of the tank, as you can see from the pictures. Eventually, this creates a gulley which can be a serious trip hazard.

1. The grooves in the floor
2. Applying the Belzona® 4131 by hand
3. Filling in the gaps by hand
4. The old and new floor, viewed at ground level

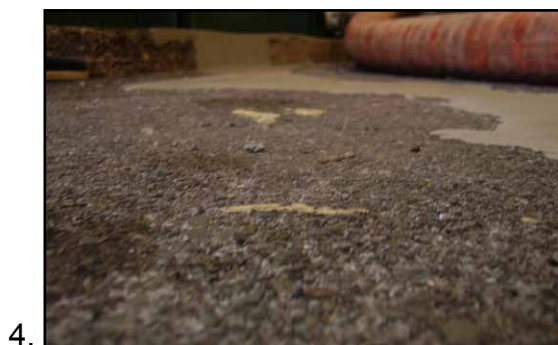
After a first inspection over a month later, the surrounding area was discolouring and graining but the reclaimed areas were standing up well to exposure to the raw cider. As a result, the client now wishes to coat the whole area once the application has proved itself, as well as the other eight planetary suites.
