BELZONA UPGRADE TO FLOOR IN CHOCOLATE FACTORY

Chocolate manufacturer, Derbyshire, UK

Floor in canteen wash area.

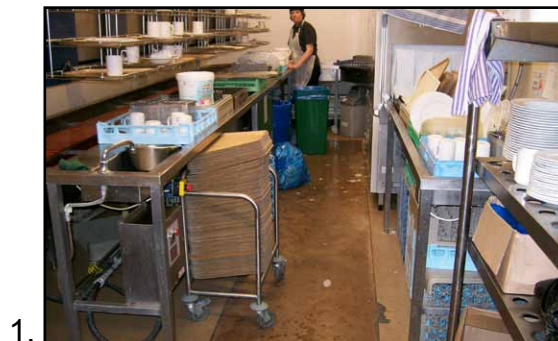
The existing coating had begun to deteriorate and sections of the main walk area had been removed exposing the concrete substrate beneath. This was not only unsightly; it also represented a health risk as staff were unable to clean the floor area adequately as food particles become trapped in the surface. The area also presented a considerable slip risk.

1. & 2. Floor Areas to be Repaired
3. & 4. Completed Floor Application

The remainder of the original floor coating was uplifted and the whole concrete floor area Application was carried out in accordance with Belzona Know-How System Leaflet FPA-3.

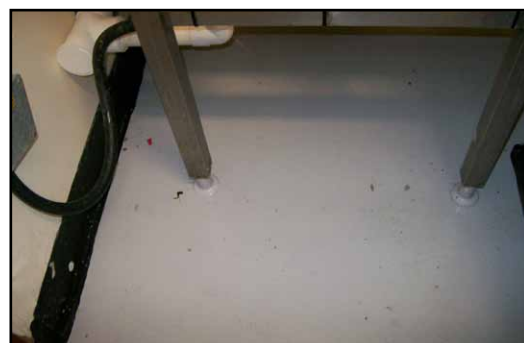
3.

The clients requirements and expectations have been met in full and they are very pleased with the results. the floor provides a hygienic surface that cannot harbour bacteria and also provides a slip resistant surface for the staff.
