BELZONA PROTECTS NEW BUILD DESALTER

Humber Refinery, UK

Humber refinery required erosion and corrosion protection of the bottom third of a new electrostatic desalter vessel.

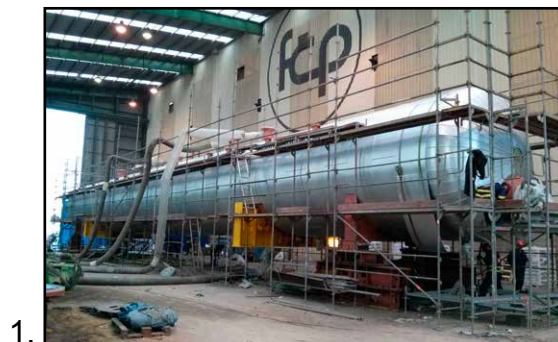
1. Desalter
2. Substrate fully grit blasted
3. Application in process
4. Finished application
