BELZONA REPAIRS AND PROTECTS PUMP CASING

Pump Casing

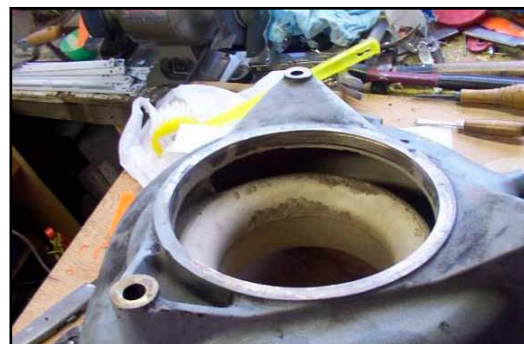
Pump casing was showing signs of degradation. This was from possible contamination during casting process.

1. View of casing showing damaged areas requiring rebuilding.
2. Application of 1st coat of Belzona 1341 in progress
3. Completed application.
