BELZONA SAVES OFFSHORE OIL & GAS PLATFORM FROM SHUTDOWN

Gulf of Mexico

September 2013

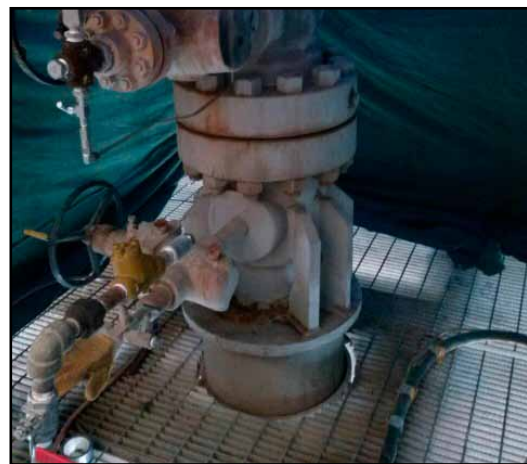
1. Photo of well conductor.
2. Photo identifying leak area.
3. Abrasive blasting in progress.
4. Completed Composite Wrap holding 85 PSI, no leaks.

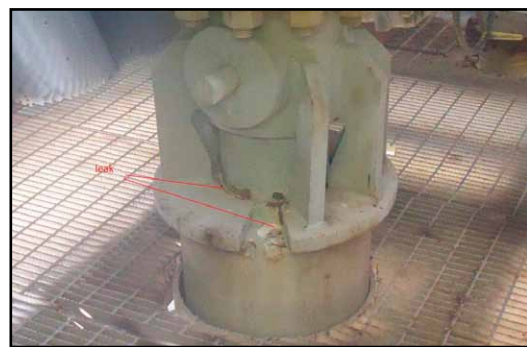
2.

External corrosion to well conductor caused natural gas leak of 85 PSI.
