BELZONA GRIP SYSTEM FOR ELECTRIC DRIVE ROLLER

Farm, Scotland, UK

February 2015

Electric drive roller on an agricultural vehicle.

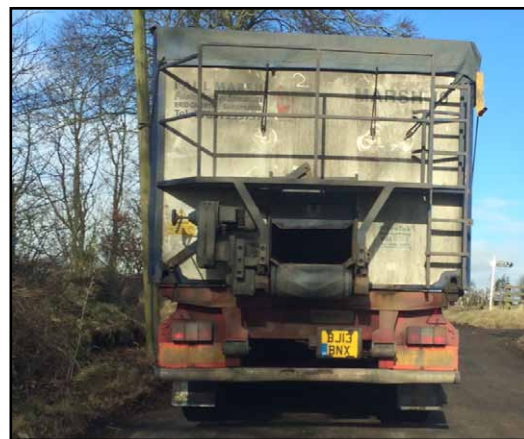
The rubber cladding on the exterior of the drive roller had failed and delaminated.

1. Drive roller on lorry
2. Drive roller prepared
3. Application of Belzona 1321
4. Completed application of grip system
