BELZONA REPAIRS TO CREAMERY MILK RECEPTION FLOOR AREA

Creamery, Stranraer, Scotland

November 2014

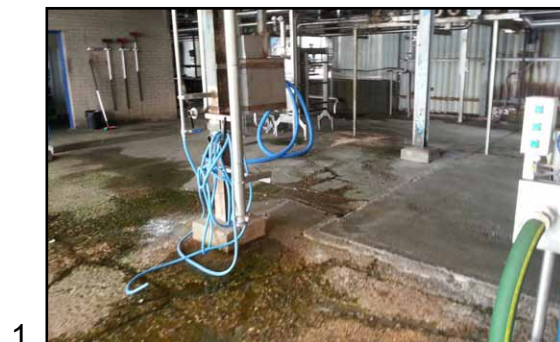
The materials had to be applied and cured in this short time frame. Over the years, the concrete floor had deteriorated due to wear, abrasion and chemical attack from the milk and cleaning fluids used. In some areas, the concrete has become cracked, and in others, it has worn down resulting in an uneven surface. An expansion joint was also in need of replacement.

1. Cracks in the concrete floor
2. Damage from loading product
3. Application of Belzona 4131
4. Completed application
