BELZONA OFFERS ANTICORROSIVE AND PEELABLE PROTECTION FOR FLANGES

Bahia, Brazil

Flanged joints connecting the pipework

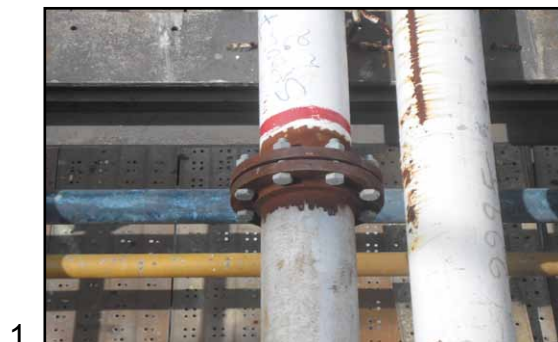
The complex geometry of the flanged joints facilitates the occurrence of problems, such as crevice corrosion in the void between the two flange faces and galvanic corrosion, where the use of different metals can create serious consequences.

1. Corroded flange
2. Application of Belzona 8411
3. Application of the second coat of Belzona 3411 (Grey) over the first coat (Beige)
4. Completed application

The application was carried out in accordance with Belzona Know-How System Leaflet GSS-11. The surface preparation was carried out manually with emery cloth according to the standard SSPC SP2/SP3, equivalent to St2/St3. After the surface was prepared and cleaned, the joints were sealed between the flange faces with tape and Belzona 8411, a corrosion inhibitor, was applied. After the protection of bolts with caps, Belzona 3411 was applied in two coats, utilizing Belzona 9311 in the circumference and in the extremities of the flanges. At the end, a visual inspection was carried out.
