BELZONA REPAIRS AND PROTECTS HEAT EXCHANGER FROM CORROSION

Tube sheets and end covers of a heat exchanger.

Pitting corrosion and bi-metallic corrosion caused leakage.

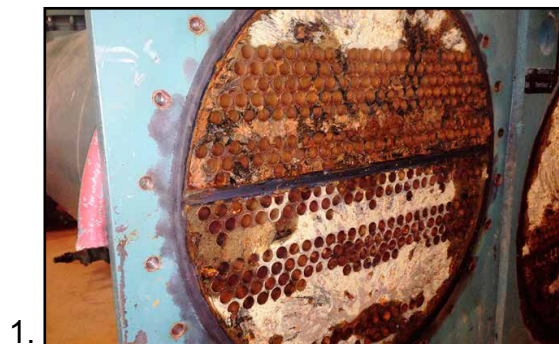
1. Prior to application
2. Prior to application
3. Application in progress
4. Completed application

The application was carried out in accordance with Belzona Know-How System Leaflet HEX-1 for repairing eroded-corroded tube sheets and HEX-3 for applying erosion-corrosion resistant coatings. The surface was abrasive blasted to prepare the area for application. Belzona 1111 was applied to the surfaces of the tube sheets and end covers to fill any pitting and damage using an applicator. Belzona 1321 was applied to the surfaces using a brush to protect against corrosion.
