BELZONA SEALS HOLE IN GLASS LINED REACTOR

Glass lined reactor.

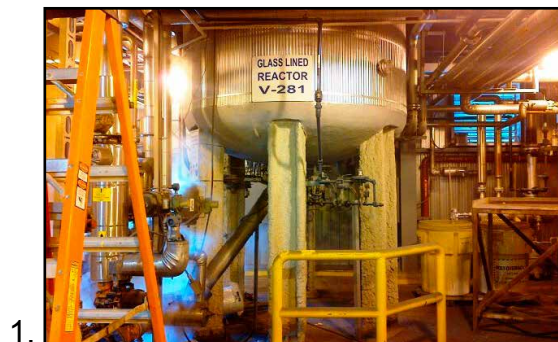
1. Overview of glass lined reactor
2. Glass lined reactor
3. Prior to application
4. Completed application

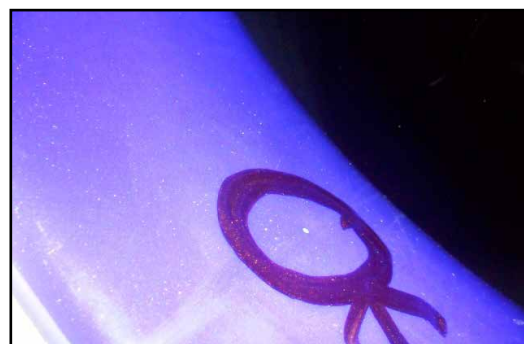
3.

Lining had suffered from impact damage, resulting in a small hole in the lining. This made the reactor unusable.

The application was carried out in accordance with Belzona Know-How System Leaflet TCC-1 for sealing cracks, porous welds, bolted and riveted joints on tanks. The surface was ground. Belzona 1591 was applied with an applicator and brush in accordance with Belzona Instructions For Use.
