BELZONA SAVES WASTEWATER GRIT PUMP

Wastewater grit pump.

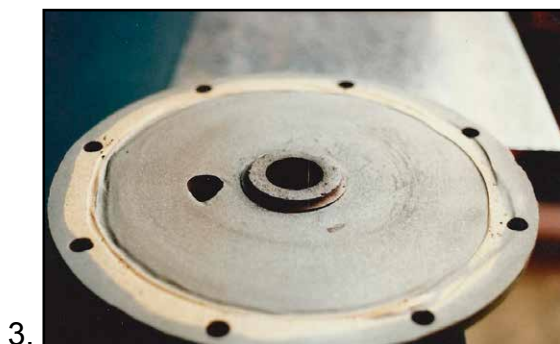
This grit pump got extremely worn and had been rebuilt with an alternative method, which lasted only 3 months.

1. Pump bowl with threads rebuilt
2. Pump bowl coated with Belzona 1811
3. End cover showing wear
4. End cover with Belzona 2111 formed in place; excess needs to be trimmed
