BELZONA OFFERS A SOLUTION TO REPAIR BUSHINGS

Worn out fork bushings.

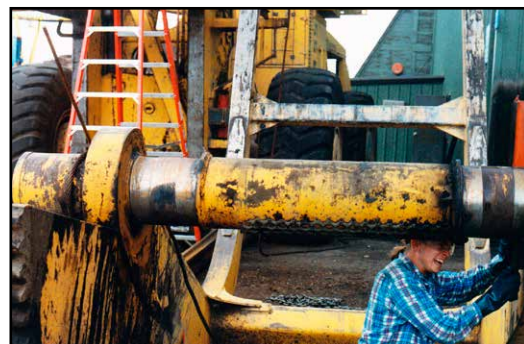
With the fork bushing worn out, the forks would bind, causing trouble unloading log trucks.

1. Worn shaft areas where bushing ride
2. Former built by their own machine shop
3. Former being bolted in place
4. Log loader ready to return to service

The application was carried out in accordance with Belzona Know-How System Leaflet MPT-2. A former was built in the machine shop and tabs were welded to center it on the "shaft".
